USDA Forest Service Region 9

White Mountain N.F.

Flood Recovery Trip Report 2018

2018 April 19

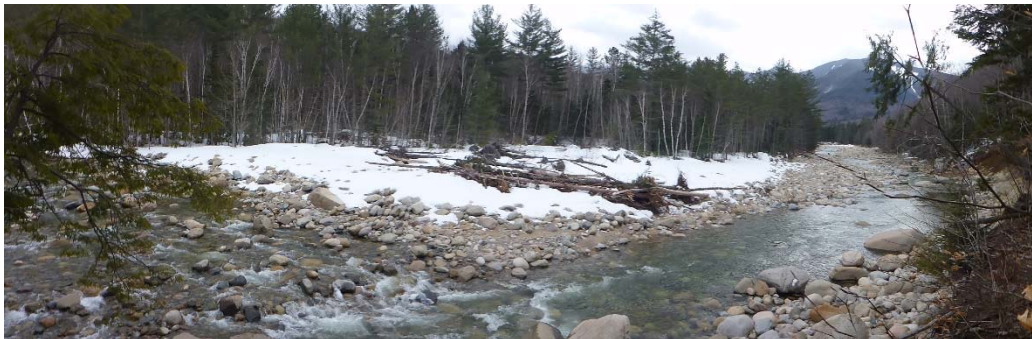
Figure 1 - View upstream of the impacted trail/road section looking downstream at the depositional bar and log jam forcing the river into the river right bank along the trail

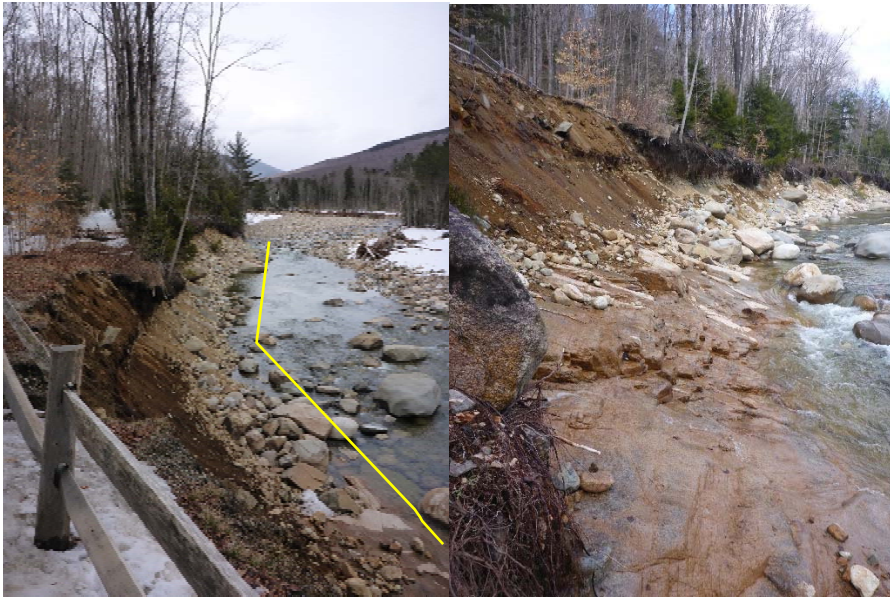
The river runs along a bank composed predominately of sand and weather granitic material with a minor component of gravel, cobble and boulders. The toe of the bank is slightly armored however the materials along the toe of the bank are mobile during elevated flows. Very few large stable boulders exist in the bank material. The right bank will continue to erode and close off access. ~100ft of trail is of immediate concern with the remaining 400ft becoming problematic in the coming years or the next large flood.

Figure 2 View looking upstream along the river bank adjacent to the trail/road. Note the fine grained materials and lack of large boulders along the toe of the bank. Yellow line designates the toe of the proposed riprap revetment

A 500ft long riprap revetment will be installed to handle flood flows and mitigate lateral migration of the river into the road/trail prism. Road/Trail width will be brought back to pre-existing width (~14ft). A short section of bedrock is exposed along 100ft section

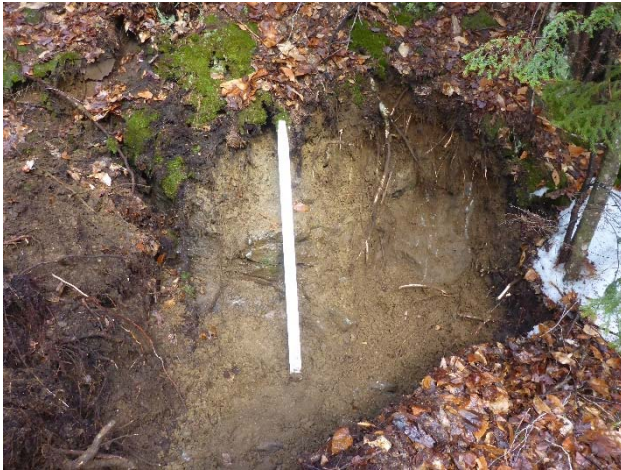
A 305 CAT excavator was used to trench 5 soil pits along the first 250ft of the project area at the greatest risk of loss. Bedrock was found to be less than 2 ft along the edge of the trail/road at stations 0+00, 0+35, and 1+00. At these stations bedrock was in fairly good conditions with minor joints / fractures ranging from 2 "to 12" plus apart. The joints were tight with no dirt or accumulation in between them. Rock is competent in this section and could be benched or used as anchor point for trail structures. (See Figure 4)

Figure 4 - Bedrock exposure at Station 0+35. A continuous fractured backwall most likely from railroad construction

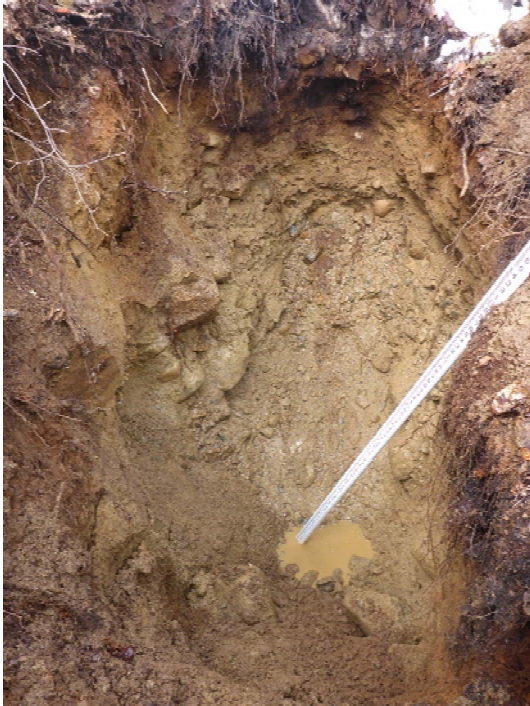
Two additional trenches were dug at stations 1+60 and 2+50. Each were excavated to 9ft deep below the existing trail grade. At station 1+60, a large flat slab was encountered at the bottom of the excavation. It appears to be of similar character to the bedrock outcrop but I cannot be assured it wasn't a very large boulder. At station 2+50, no bedrock was encountered. (See Figure 5) All material above the bottom of the trench had the same composition as is observed

Figure 5- Station 2+50 trench. No bedrock observed, material was primarily sand with gravels, cobbles, and boulders

considered, additional geotech work will need to occur. Either ground penetrating radar or wireline core sampling will be needed to determine the depth to competent bedrock from station 1+60 to 2+50 and beyond.

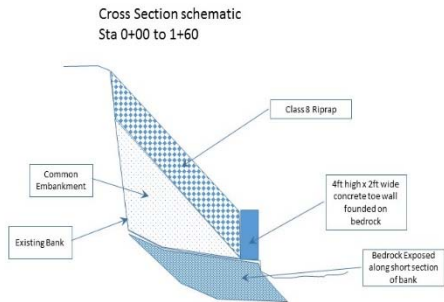
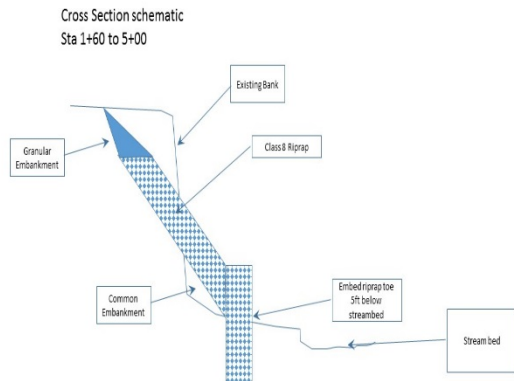
Figure 6 - Cross section schematics for riprap revetment along the eroding section of trail/roadway.

of the road/trail. A 4ft high concrete toe wall will be constructed to stabilize and buttress the riprap toe to prevent sliding and revetment failure. The bedrock changes to alluvial bottom at about station 1+15. Along the alluvial section, the riprap toe will be embedded ~5ft below streambed elevation.

A separation geotextile will be used to prevent fine grained material loss behind the riprap. Figure 6 shows a schematic of the cross sections.

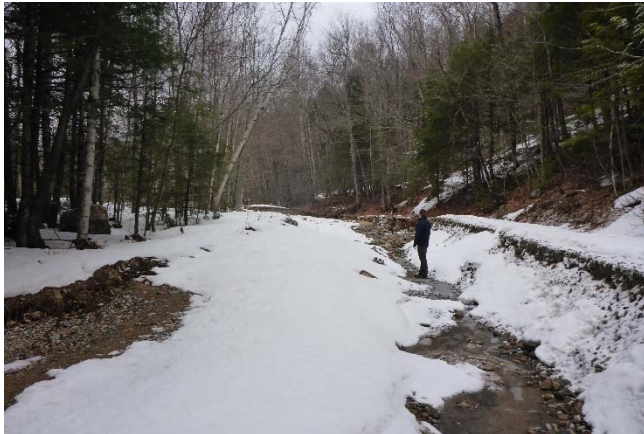
During the overbank flooding more erosion occurs adding more sediment to downstream reaches. Local recruitment of large wood occurs more frequently since the river can gain access to the banks and root systems easier than in normal conditions. All this produce a negative feedback of channel infilling and avulsing to a new channel position which will be the road since it is the waters path of least resistance. Figure 7 shows one section where the river avulsed on the flood plain and cut a 4ft deep channel thru the road prism.

Figure 7 - Road washout area. The channel bed is almost as high as the floodplain in this section. The channel has aggraded and the river goes overbank during lower than normal flood levels. The river cut down thru the road bed about 4.5 ft. in depth for several hundred feet.

The roadway can be reconstructed but will still be subject erosion and damage during floods. If the road is reconstructed it should be relocated in places, have a levee system added along sections imminently at risk, and the bridge on Rocky

Remove the Rocky Branch and Otis Creek bridges. Remove all culvert drainage structures and construct dips. Place large wood on the floodplain and decommissioned roadway to discourage the road from becoming a primary flow path.

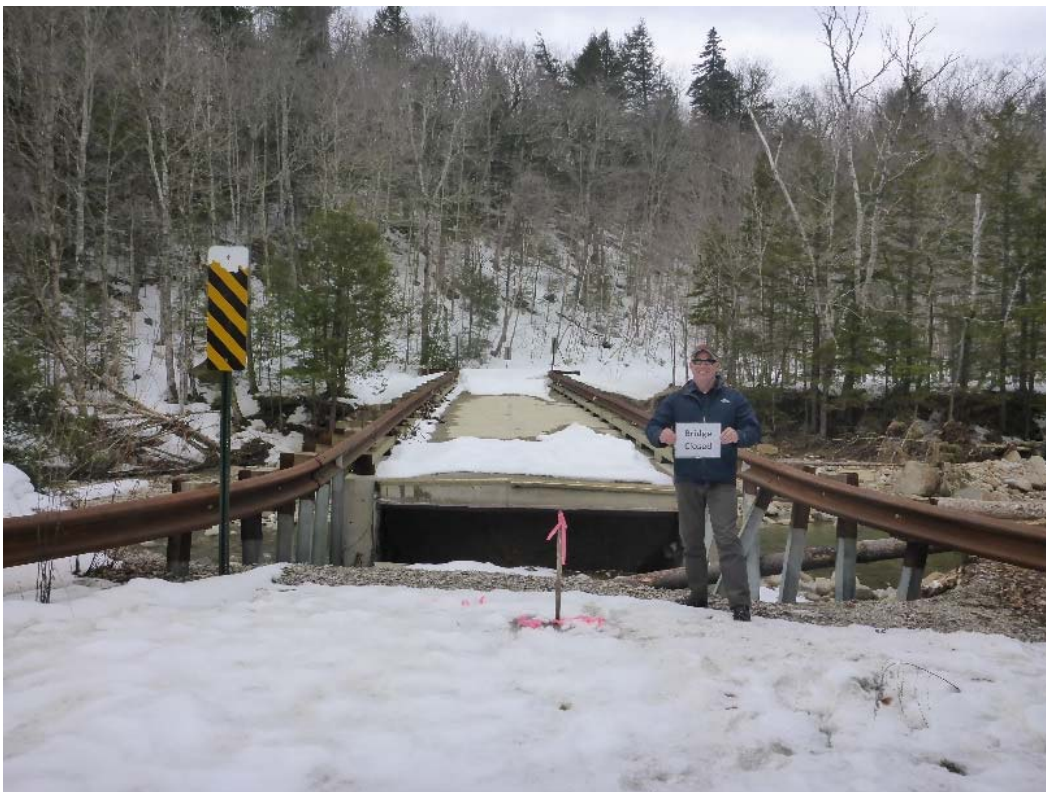
Figure 8 - Rocky Branch Bridge near road approach. Both abutment approaches were washed out and the abutment structure sustained damage to the concrete backwalls.

The bridge can be decommissioned and removed. The concrete deck and abutments will be unusable and can be broken up and used as bank protection, buried, or hauled offsite. The girders can be reused at another road crossing.

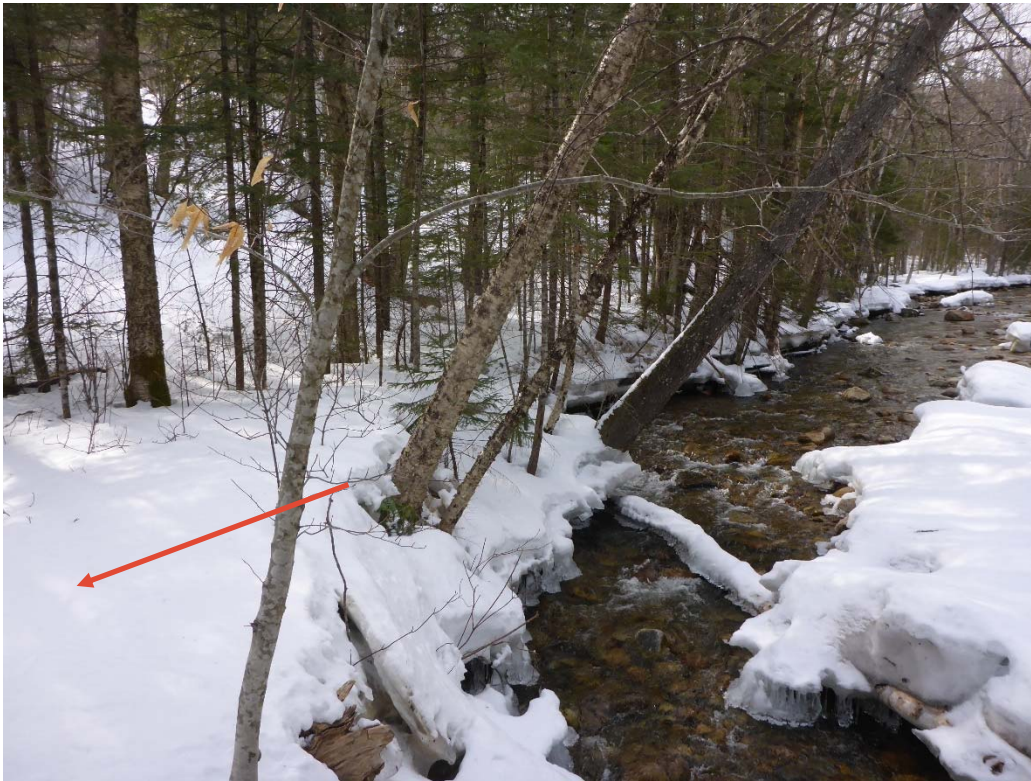
The sediment has stalled at this location and is causing more frequent overbank events. Trees along the banks are eroding and at risk of falling into the river causing further aggradation upstream (See Figure 9). With diminished hydraulic capacity of the old channel, likelihood of avulsing across the paved road is high and will continue to increase in time.

Figure 9 - Location of potential avulsion. Note the trees undermining upstream and the very low relief of the top of the bank to the stream bed elevation. Red line indicates the avulsion flow path.

The solution for a relatively long period of time is to raise the road grade at the junction of the Tripoli and Livermore roads. The road elevation should be increased to the maximum extent possible at this location. The increase will be on the order of about 3ft. The increased roadway elevation should extend beyond Tripoli road junction then change grades to tie into the original road elevation. A large pipe arch, elliptical, or box culvert can be installed to handle increased flood flow from more frequent overbank events.

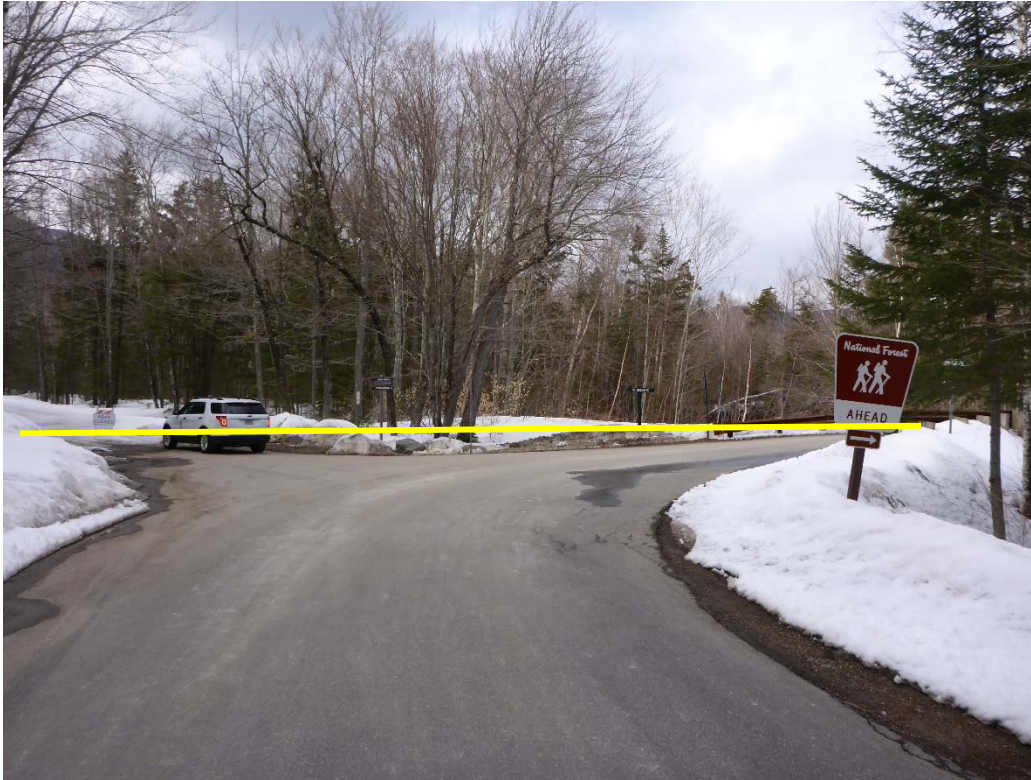
Recent signs of overtopping was observed at the location. The Bridge hydraulic capacity is most likely undersized compared to current standards. The road approaches on the river right side will avulse frequently since bank height is only a foot or so above the active floodplain.

It was reported that this section of road has been a chronic problem and is much more active since the floods in 2011 and 2017 occurred. (See Figure 10)

Figure 10 - Tripoli and Livermore Road junction at the avulsion location. This view is downstream looking upstream at the junction. Raise the road grade to ~ the yellow line. Install the largest pipe arch or elliptical pipe possible under the Livermore road while maintaining 18" of cover on top of pipe or to manufactures recommendations. Construct a flood channel to the river from the outlet of the pipe.

A flood channel should be constructed from the new culvert outlet to the river channel. Trees in the path should be removed and a small flood channel constructed. At the inlet construct a small riprap apron to protect the pipe against scour.

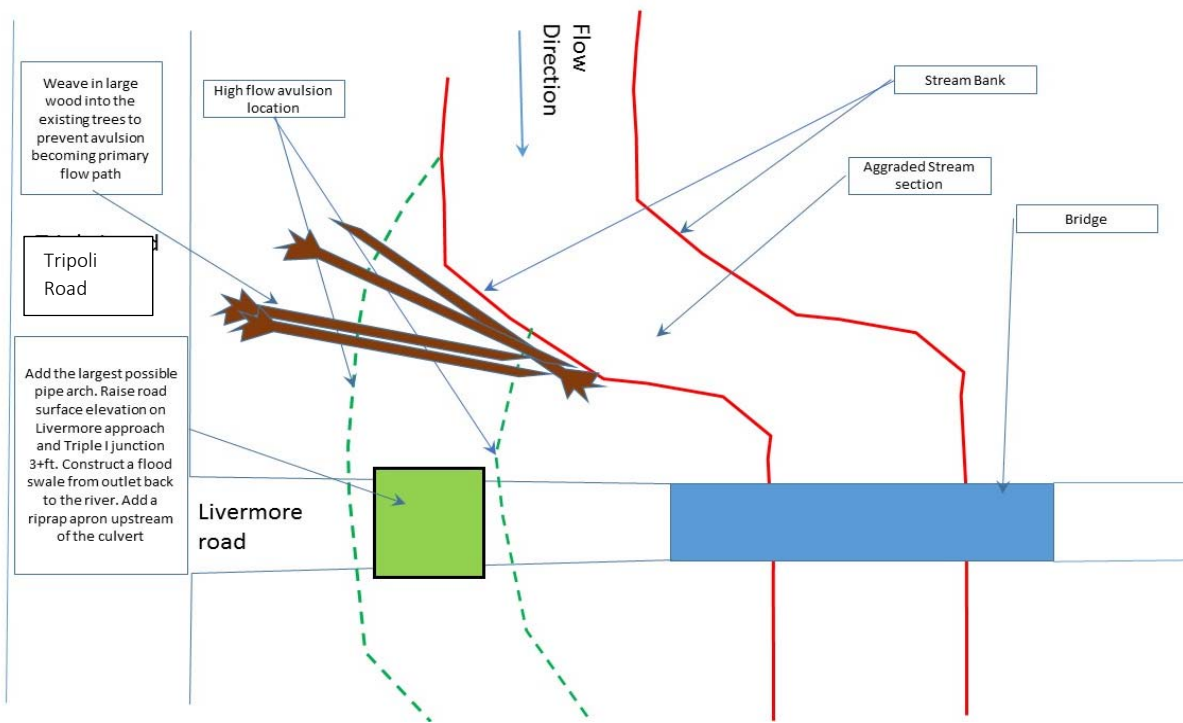
Figure 11 - Schematic plan view of conceptual proposed solution to overbank flooding the roadway at Triple I and Livermore road junction

In the area upstream of the culvert, place large wood trees with root fans attached. Weave the logs into the trees on the floodplain. This is to help ensure that the river has flood access to the new culvert but the avulsion path doesn't become the primary flow path. See Figure 11 for schematic layout out of proposed repairs

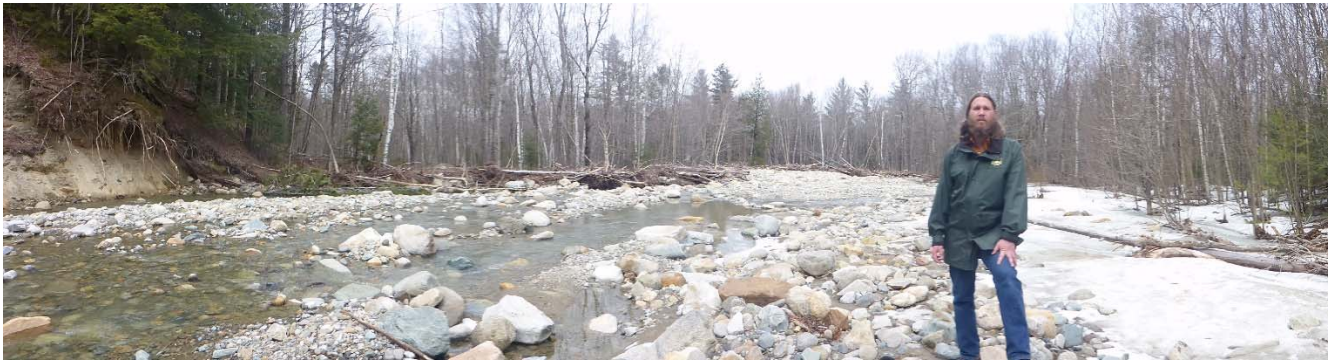
Figures 12, 13, and 14 show river sections that have aggraded up to the top of the river bank and large alluvial fan deposition zones in the section downstream from the decommissioned road and adjacent to the county road section.

Figure 12 - Panoramic view looking downstream on lower Tunnel Brook. Note no visible bank height exists. Possible 1 ft or so of relief at a maximum. This makes overbank flows common during lower than normal flood flows. Log jams are also visible in the photo.

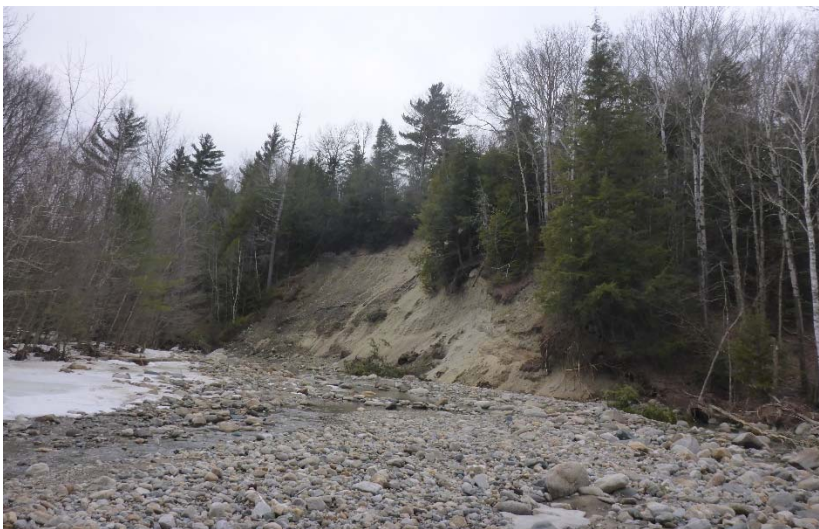
Figure 13 - Sediment and log source area from mass wasting along Tunnel Brook caused by floods.

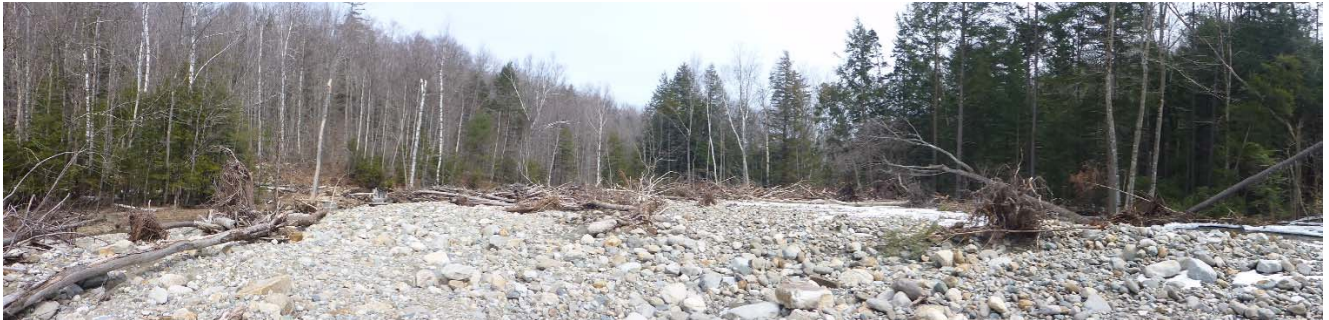
Figure 14 - Large alluvial fan has formed immediately upstream of the Town Bridge on Tunnel Brook. Sediment has built up 6 to 8ft in places and numerous cross valley log jams have formed helping to retain sediment on the alluvial fan.

The large alluvial fan growing and expanding downstream to the Tunnel Brook Town Bridge is a concern. On and upstream of the fan, log jam structures can be built that would catch trees moving downstream and help the channel to aggrade headward. This would help increase sediment storage time upstream and allow sediment getting to the bridge to be processed more readily. Figure 16 shows Lateral bar jams installed in Missouri used to recruit wood and store sediment upstream of sensitive habitat for Ozark hell bender. The same techniques can be employed on and upstream of the alluvial fan to store sediment.

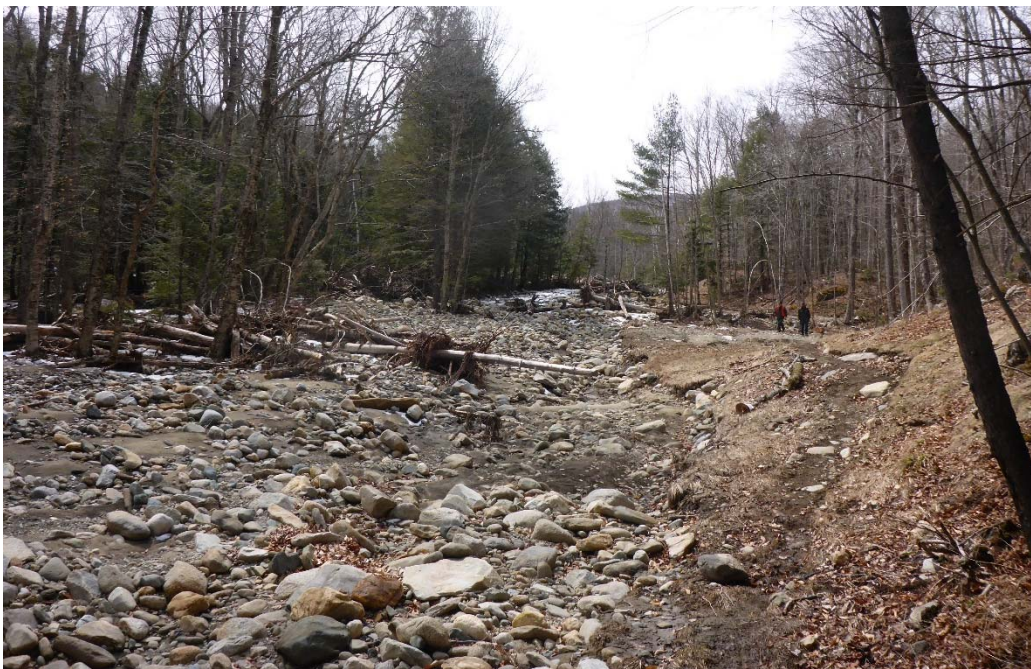
Figure 15 shows the channel section between the large alluvial fan in Figure 14 and the Town Bridge.

Figure 15 - Channel section downstream of the large alluvial fan on Tunnel Brook. This section of channel is accumulating wood and aggrading sediment.
